INTI INTERNATIONAL UNIVERSITY

**ACID MINE DRAINAGE AND HEAVY METALS CONTAMINATION
OF ABANDONED AND ACTIVE MINE SITE AT OLD REPAS DAM IN
BENTONG PAHANG MALAYSIA**

Final Year Project

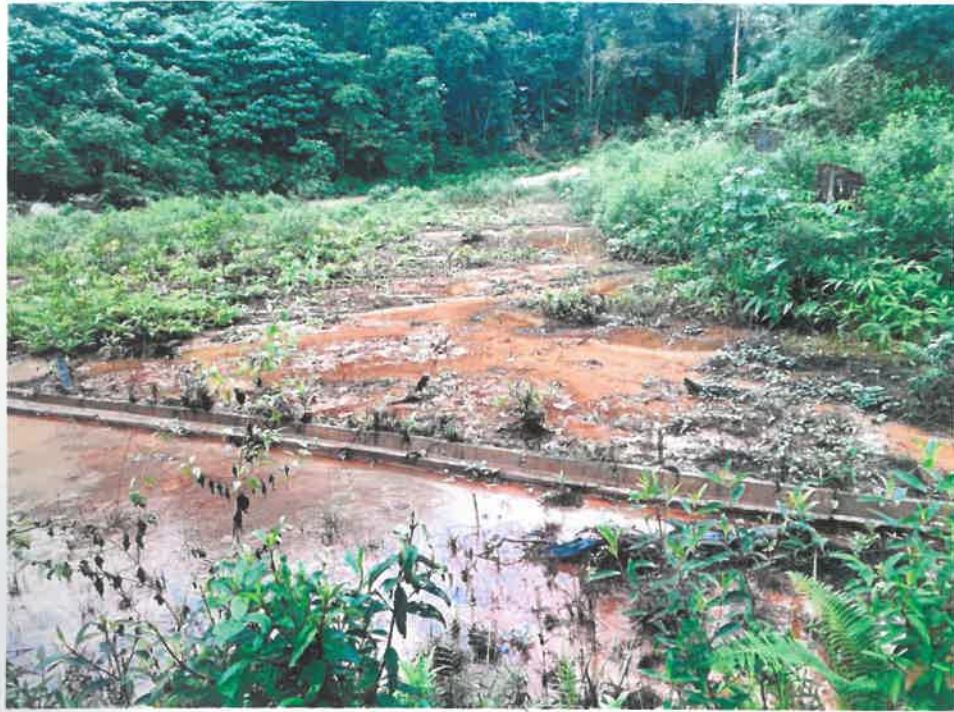
Figure 1.2: Current Issue

Due to heavy mining in Pahang, there are several mines that are abandoned without closing down in an appropriate way because the previous mining regulations were not enforced or carried out properly. Bukit Ibam is one of those mining sites. Currently, Environmental Quality Act (1974) and Mineral Development Act (1974) have been established to avoid abandonment and Contamination from mine activities in Malaysia. The Old Repas Dam (1925) and The New Repas Dam (1963) was built or constructed for the same purpose that is silt retention. New Repas Dam is constructed at a very near distance to the Old Repas Dam and it controls the flow of water into the Dam. Old repas down was abandoned or closed down due to some seepage issues.

Several activities such as land development, mining and agricultural works being carried out on the upstream of the Old Repas dam in Bentong, Pahang are causing the deterioration of the water quality and it is contaminating the water bodies by the heavy metal toxins found in the wastewater (acidic water) and by surface runoffs occurring due to precipitation. This waste water would end up in the dam and it will affect the aquatic life. This Dam was constructed to hold residue, dirt and silt from the previous tin mining activities that has been washed down by surface runoff and prevent it from being washed downstream and block the lower part of the river which may cause flooding. The water downstream of The Old Repas dam was reported to be discoloured and polluted as it can be seen in Fig 1.2. This Discoloration of water shows traces of AMD contamination and is likely to contain high concentration of Ammoniacal Nitrogen. Even the grass around that area dies because of the polluted water, as it has no life.
