Geospatial Assessment of Road Pavement Distress at Jahangirnagar University Campus

This study assesses the types, causes, and spatial distribution of pavement distress across six key road segments of the JU campus, aligning with the objectives of SDG 9 (Industry, Innovation, and Infrastructure) and SDG 11 (Sustainable Cities and Communities) to promote resilient and sustainable infrastructure systems. A mixed-method approach was employed, integrating direct field observation, photographic documentation, literature review, and geospatial mapping. Pavement distresses were classified into eight major categories: thermal cracking, warping cracking, longitudinal cracking, bleeding, stripping, raveling, pumping, and blistering. GPS coordinates were recorded using handheld devices to create georeferenced maps illustrating the spatial distribution of distress points. Data from six road sections—covering a total of 987.3 square meters—revealed 206 distress cases, with stripping (47), thermal cracking (39), and raveling (37) as the most prevalent types. These conditions were primarily influenced by temperature fluctuations, drainage inefficiencies, and material aging. Findings emphasize the

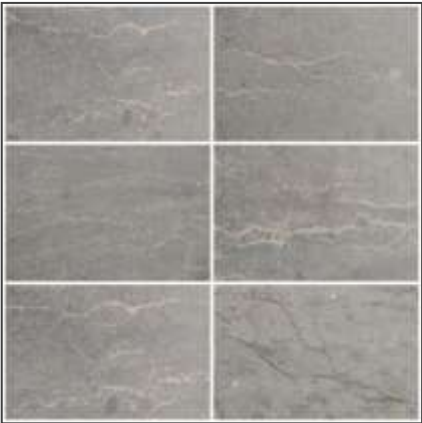
Type	Causes	Image
Thermal Cracking	<p>Extreme Temperature Fluctuations: JU experiences significant temperature variations between day and night, causing expansion and contraction of pavement materials leading to cracks.</p> <p>Insufficient Temperature Control Joints: Lack of proper joints or spacing in rigid pavements fails to accommodate thermal movements.</p> <p>Low-Quality Bitumen: Use of bitumen with low temperature susceptibility causes it to become brittle in colder conditions.</p>

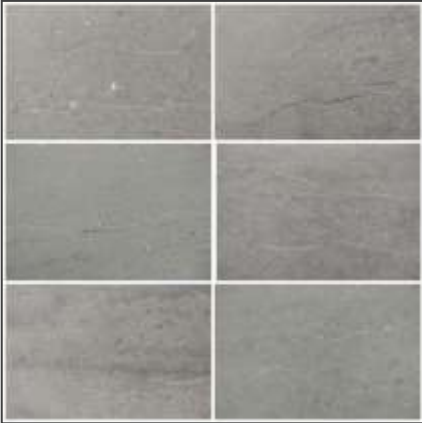
Warping Cracking	<p>Moisture Gradient: The clayey soils found in parts of JU create uneven moisture profiles beneath pavements, leading to slab warping.</p> <p>Temperature Differential: Slabs expand on the top due to heat but stay cool at the bottom, inducing stresses that cause warping cracks.</p> <p>Inadequate Slab Thickness: Thin concrete slabs are more susceptible to warping under thermal and moisture gradients.</p>

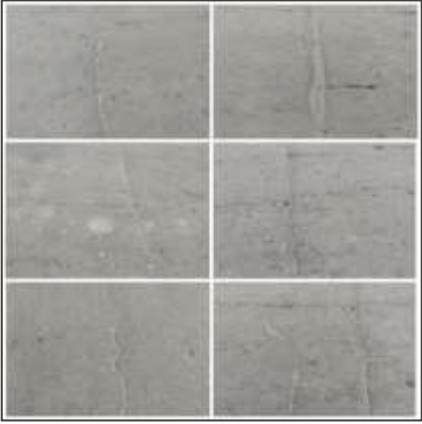
Longitudinal Cracking	<p>Subgrade Settlement: Weak or poorly compacted subgrade layers in JU's older roads cause differential settlement along wheel paths.</p> <p>Poor Construction Practices: Inadequate joint construction or improper compaction leads to cracking along the pavement's centerline or wheel paths.</p> <p>Heavy Traffic Loads: Continuous movement of heavy vehicles like</p>

campus buses and supply trucks
exacerbates stress along the
pavement length.

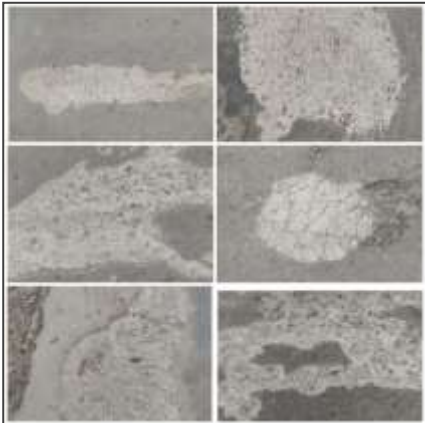
Type	Causes	Image
Bleeding	<p>Excess Asphalt Binder: Over-application of asphalt during construction or maintenance results in asphalt binder migrating to the surface.</p> <p>Hot Weather Conditions: High temperatures soften the binder, causing it to bleed to the surface, especially in summer months.</p> <p>Low Air Voids in Pavement: Dense mix designs with inadequate voids prevent binder absorption, increasing bleeding risk.</p>

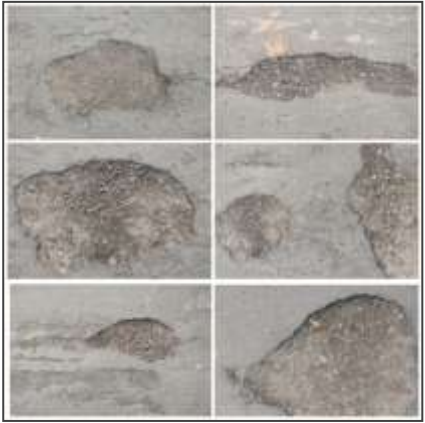
Type	Causes	Image
Stripping	<p>Poor Drainage Conditions: JU roads often have waterlogging issues during the rainy season, leading to water intrusion that weakens the bond between aggregate and binder.</p> <p>Inadequate Compaction: Poor compaction allows moisture infiltration, promoting stripping.</p> <p>Use of Non-Stripping Resistant Aggregates: Some locally sourced aggregates may lack anti-stripping agents, worsening the problem.</p>

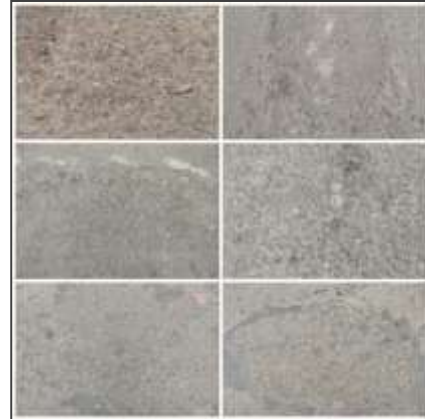
Raveling

Aging of Asphalt Binder:

Oxidation of the asphalt binder over time leads to loss of adhesion, causing aggregates to dislodge.

Low-Quality Mix or Workmanship: Poorly designed asphalt mixtures or improper laying techniques lead to weak surface bonding.

Heavy Traffic Wear: Constant movement of heavy vehicles around the main gates and dormitory areas causes surface deterioration.
